TVA valve and boost pressure sensor cleaning procedure

(R750EU6 engines)

SA 26.03.2019 / rev.02

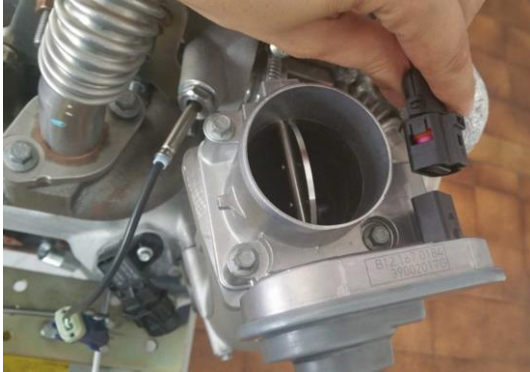
A
Disconnect
the plug

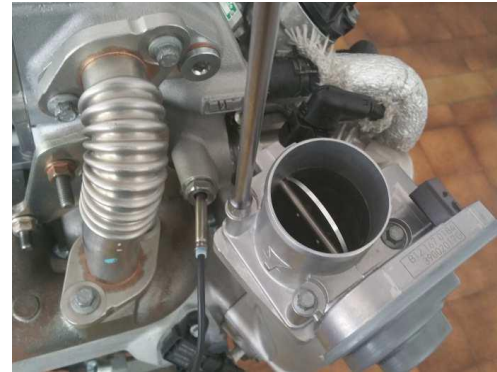
B
Loosen the 4
screws with an 8
mm wrench

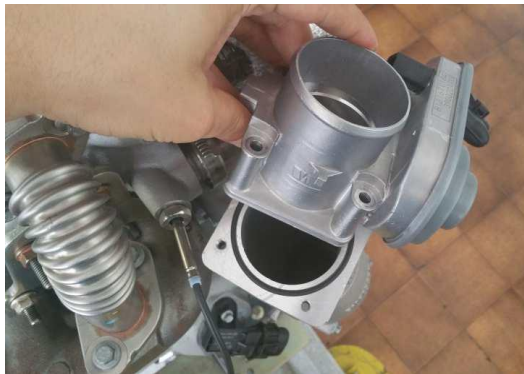
C
Remove
the TVA

- Make sure to remove the elbow sealing (cap)
- Make sure to install the new O-ring.
- Reinstall the valve in reverse order starting with point C on page 3

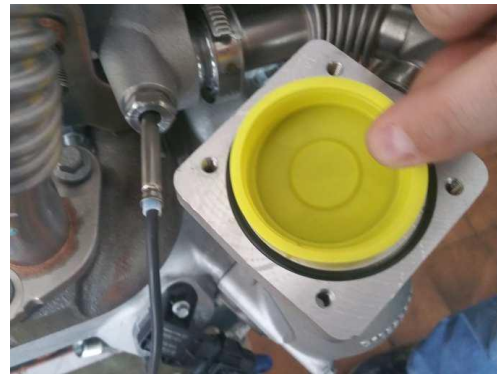
D
Seal the intake
elbow with an
appropriate
cap to prevent
foreign material
ingestion

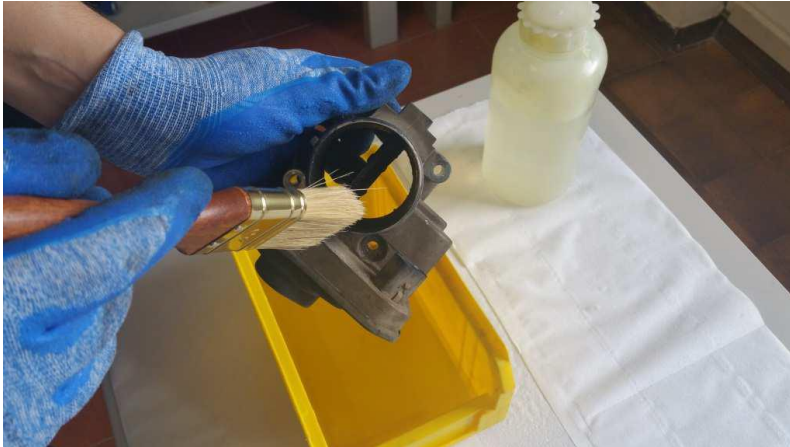
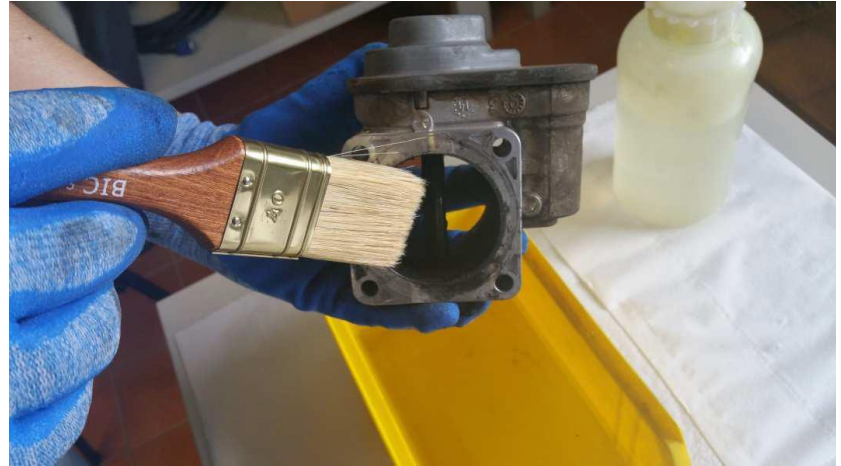
Clean the valve with degreaser

Attentions!
To avoid damage to electrical parts, do not completely immerse the valve in the solvent.

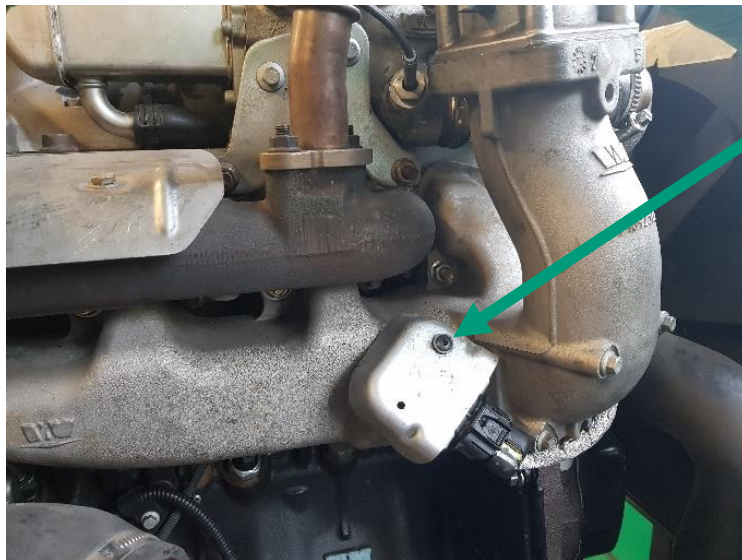
Loosen the screw

Loosen the screw
with a 3 mm hex-
wrenge
